D. GEORGE STREET TRENCH

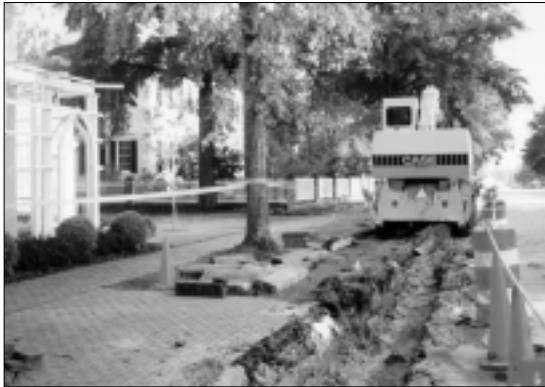
Figure 67. Mechanical excavation of the George Street Trench, view north.

The last phase of this street improvement project consisted of the excavation of approximately 100 feet of trench along the west curb of George Street. This section of work began at the drain box located at the northwest corner of the intersection of Pollock and George Streets, approximately 40 feet north of datum point 3. The width of this trench was reduced to three feet in order to avoid difficulties that may have resulted during the removal of concrete paving (Figures 67 & 68).

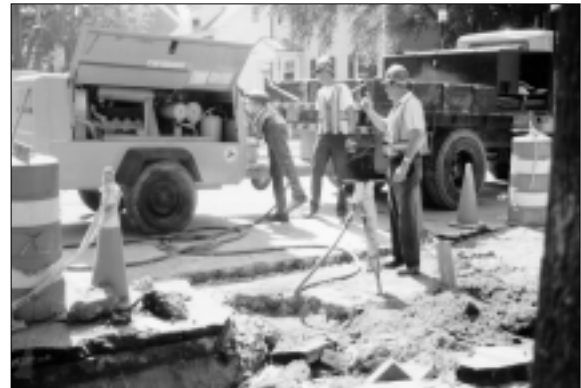
Figure 68. Removal of concrete pavement overlying Feature 10, view southeast.

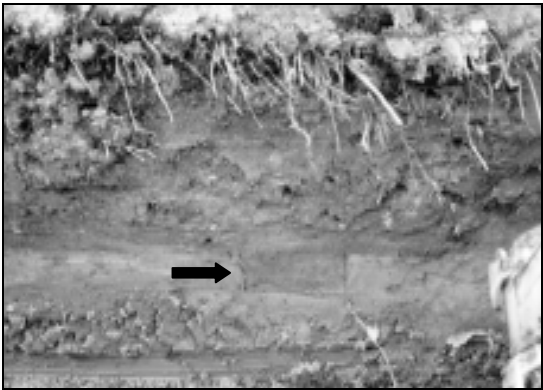
Figure 71. West profile of Feature 13.

Five features were documented in the George Street Trench (Table 26), this included Feature 10 that was located at the intersection of Pollock and George Streets. Feature 10 is a section of cobblestone paving covered with one course of brick bats. The remaining four features were post holes (Features 11-14) in the west profile. Of these, two (Features 13 and 14) were located in the last 25 feet of the trench. These two features were photographed but not mapped before the trench walls collapsed (Figures 71 & 72).

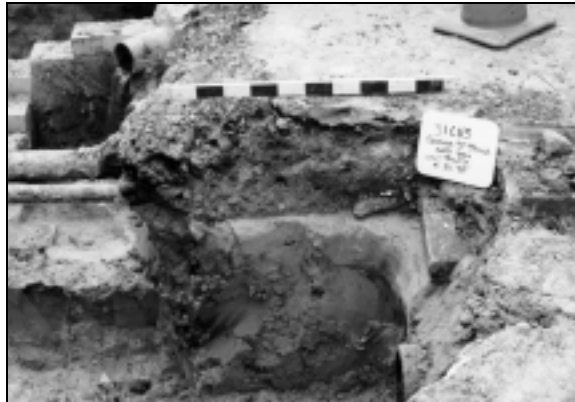
Figure 73. West profile at the intersection of Cross Pollock & George Street trenches.

Inspection and documentation of **Feature 10** was conducted in the most unusual circumstance encountered throughout the project. A large pit had been opened by the backhoe to facilitate extensive utility work including the replacement of a catch basin (Figures 73-80). Feature 10 was exposed in the east profile of this pit. Part of Feature 10 had been removed by the backhoe before the significance of the ballast stone became apparent. Documentation consisted of photographing the surrounding walls and mapping the east profile.

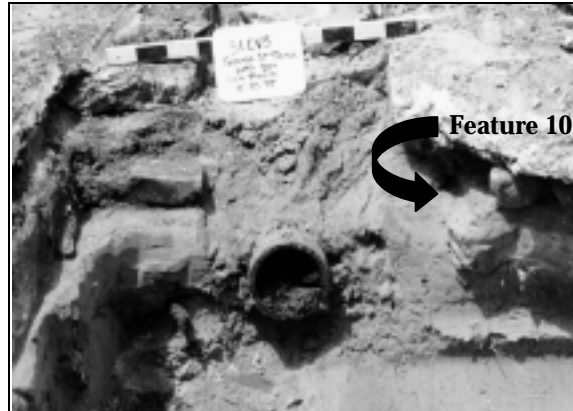
Figure 74. North profile at the intersection of Cross Pollock & George Street trenches.

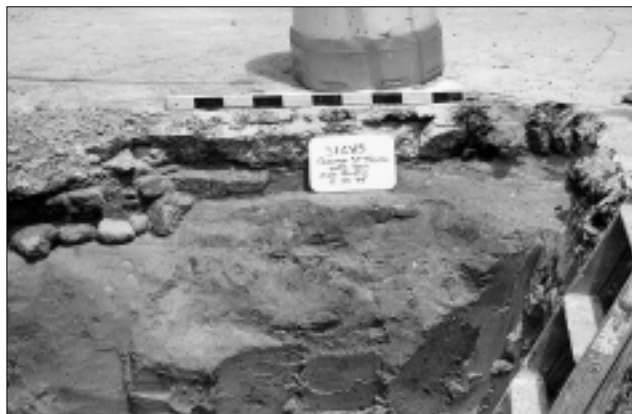
Figure 76. East profile at the intersection of Cross Pollock & George Street trenches.

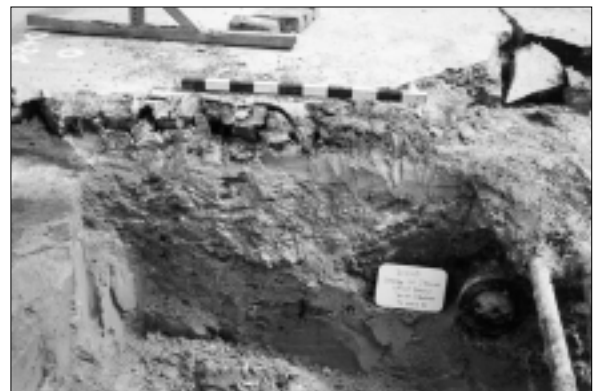
Figure 75. South profile at the intersection of Cross Pollock & George Street trenches.

Just south of Feature 10, four soil zones were recorded (Table 27). Materials noted, but not recovered, include brown salt-glazed stoneware and burned pearlware or whiteware in zone 1 and creamware in zone 2. No cultural material was seen in zone 3. Attempts to pursue recovery were held back by the threat of a wall that undercut the pavement.

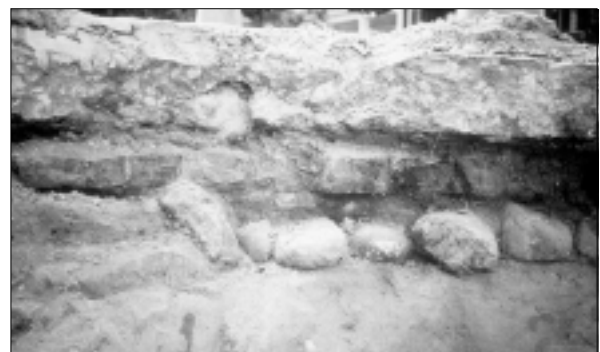
Figure 77. West profile of Feature 10 at the Pollock Street & George Street intersection. (Photo by John Green, on file at Tryon Palace Commission House, New Bern)

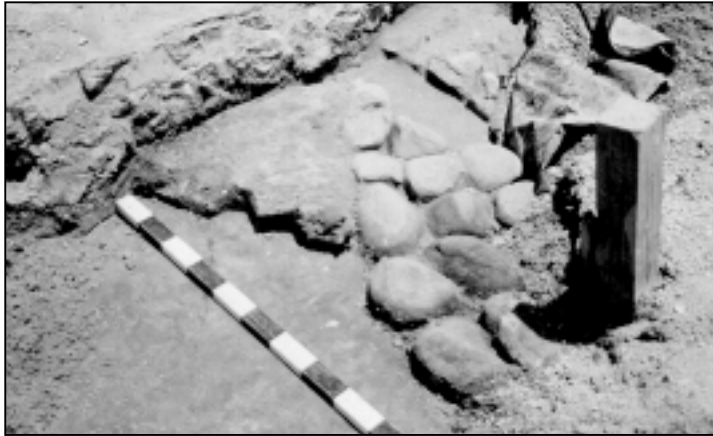
Figure 79.
Plan view of Feature 10, view southeast.

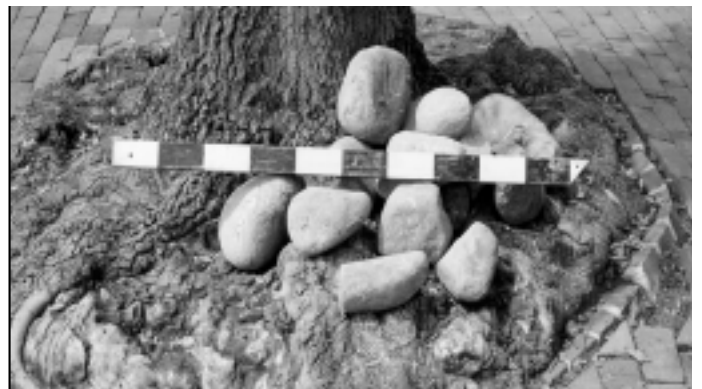
Figure 80. Ballast stone from Feature 10.

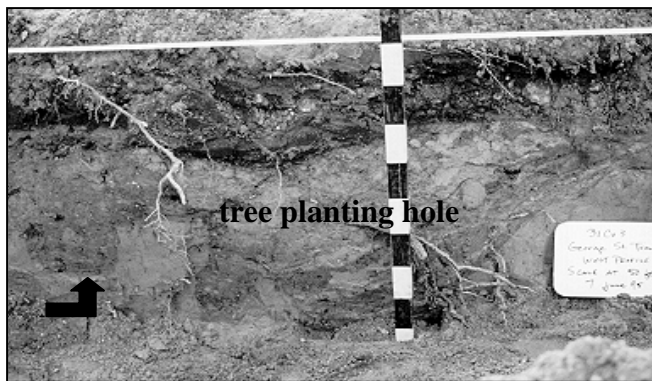
Figure 81. West profile of Feature 11 and
planting hole.

As viewed in the west profile of the trench, **Feature 11** was a post hole (Figure 81). It was recorded between 47 feet and 47.8 feet north of datum point 3. The matrix of the feature is a mottled grayish brown (10YR 5/2) and yellowish brown (10YR 5/6) sandy loam. The top of the feature was difficult to determine because the post hole was filled with soil that appeared in the overlying zone. The matrix of this feature and the overlying zone is a coarse grayish brown (10YR 5/2) sand containing crushed shell and brick fragments. The feature extended to a depth of 1¼ of a foot below surface into the yellowish brown (10YR 5/6) subsoil. Cultural material recovered from the profile of this feature consisted of small fragments of brick and one piece of coal (Provenience GST 4: Appendix B, Table 53).

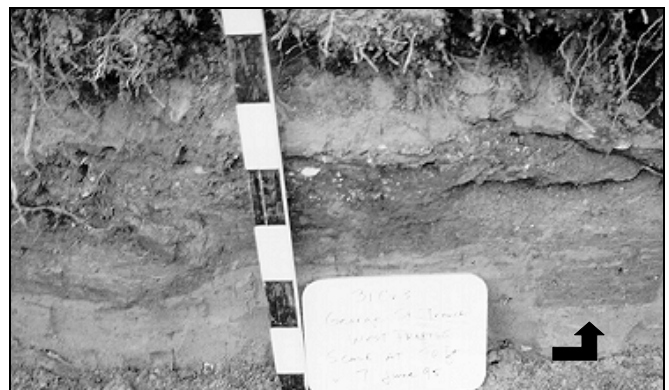
Figure 82. West profile of Feature 12.

A second post (Figure 82) was recorded as **Feature 12** in the west profile of the George Street trench between 71 and 72.3 feet north of datum point 3. The matrix of the feature is a mottled grayish brown (10YR 5/2) and yellowish brown (10YR 5/6) sandy loam. This feature began at 1½ feet below surface and continued to 2.7 feet below surface, terminating in the yellowish brown (10YR 5/6) subsoil. The tan sandy loam mortar and brick zone post-dates this feature.
